**Research and
Special Programs
Administration
John A. Volpe National
Transportation Systems Center
Cambridge, MA 02142-1093**

**Final Report
September 1992**

7. PERFORMING ORGANIZATION NAME(S) AND ADDRESS(ES) U.S. Department of Transportation Research and Special Programs Administration Volpe National Transportation Systems Center Cambridge, MA 02142-7093			8. PERFORMING ORGANIZATION REPORT NUMBER DOT-VNTSC-FAA-92-6

9. SPONSORING/MONITORING AGENCY NAME(S) AND ADDRESS(ES) U.S. Department of Transportation Federal Aviation Administration 800 Independence Avenue, S.W. Washington, DC 20591			10. SPONSORING/MONITORING AGENCY REPORT NUMBER DOT/FAA/W/92-1

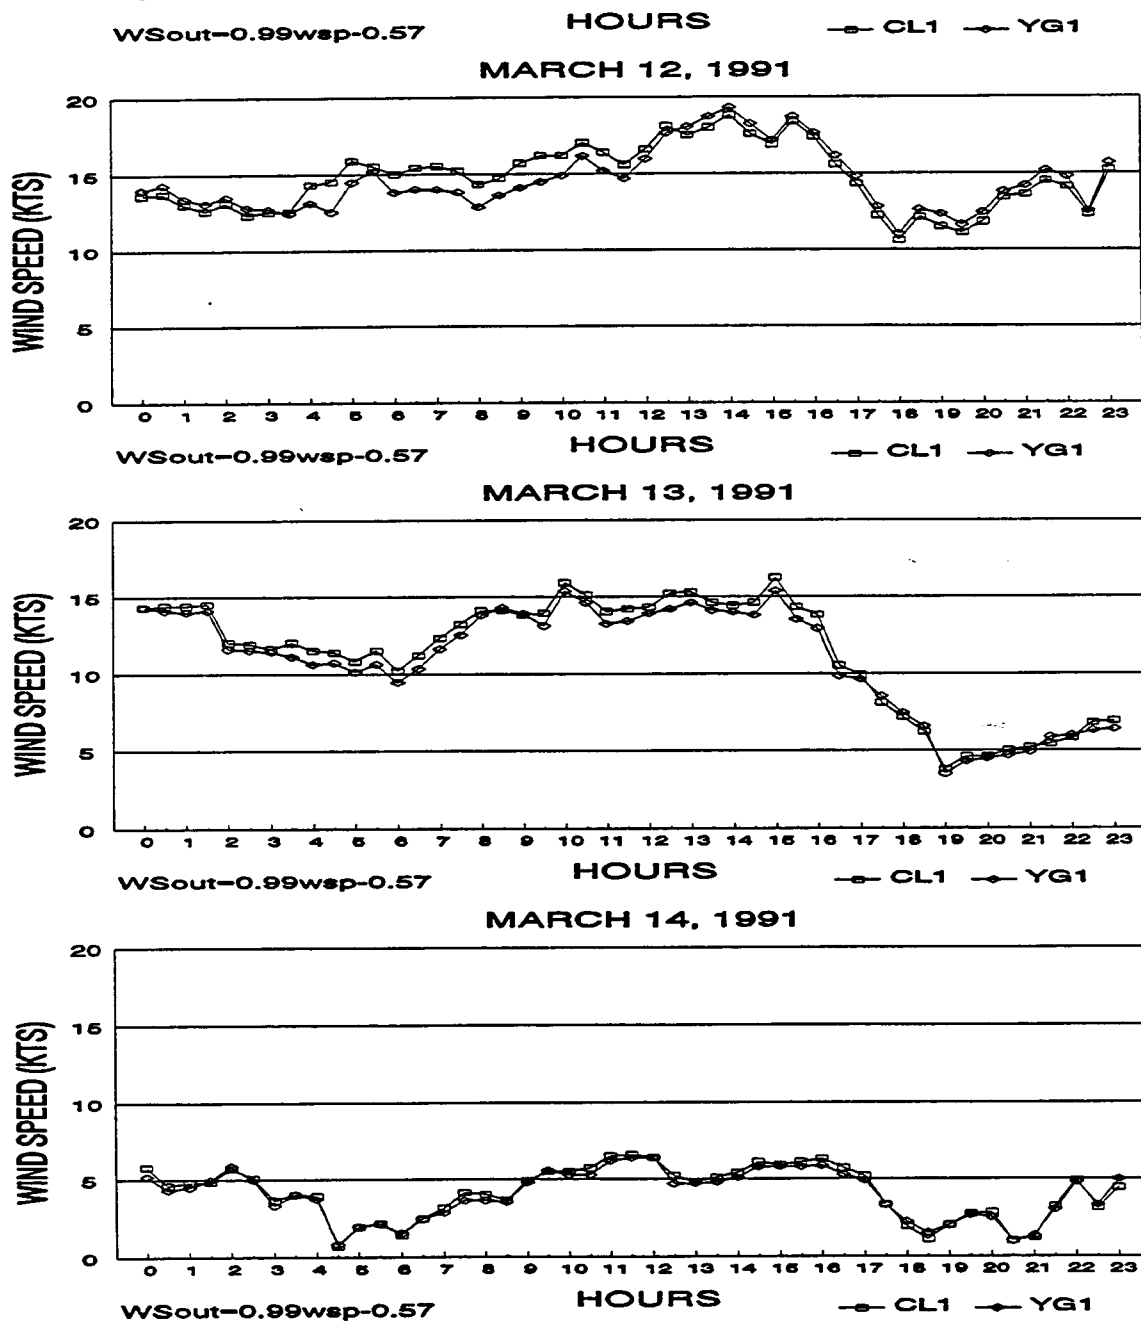
FIGURE 4-13. COMPARISON OF YG1 AND CL1 WIND SPEED ON 3/11-14/91

4.4.3.3 3/12/91 Snow Event - The March 12, 1991 snow event is an interesting case study because there is evidence of effects on the two Vaisala cup anemometers, probably due to blowing snow. The snow event follows the icing period in Section 4.4.3.2. The wind conditions were similar (Figure 4-12) and the same comments on the other sensors pertain.

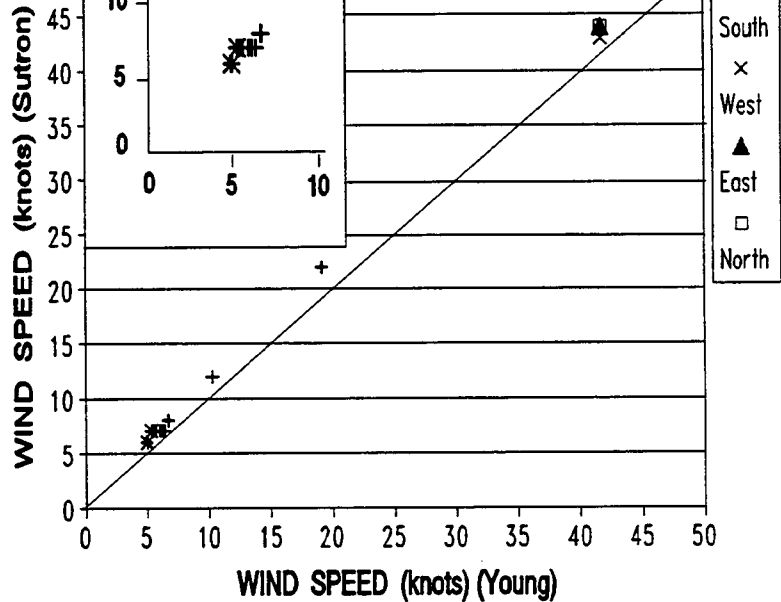
FIGURE 5-3. SUTRON CALIBRATION(S/N 90SC1)

The Sutron and Armtec field test readings of two knots higher than all the other sensors were substantiated for both sensors at low wind speed as shown in Figures 5-3 and 5-4.

Most of the Sutron data was for one direction (south). The Sutron sensor was reading almost 2 knots higher than the R.M. Young reference for winds below 15 knots. The error became larger for higher wind speeds, reaching an error of about 7 knots at a reading of 42 knots. The spread in calibration for different directions at 42 knots was about 5 knots.

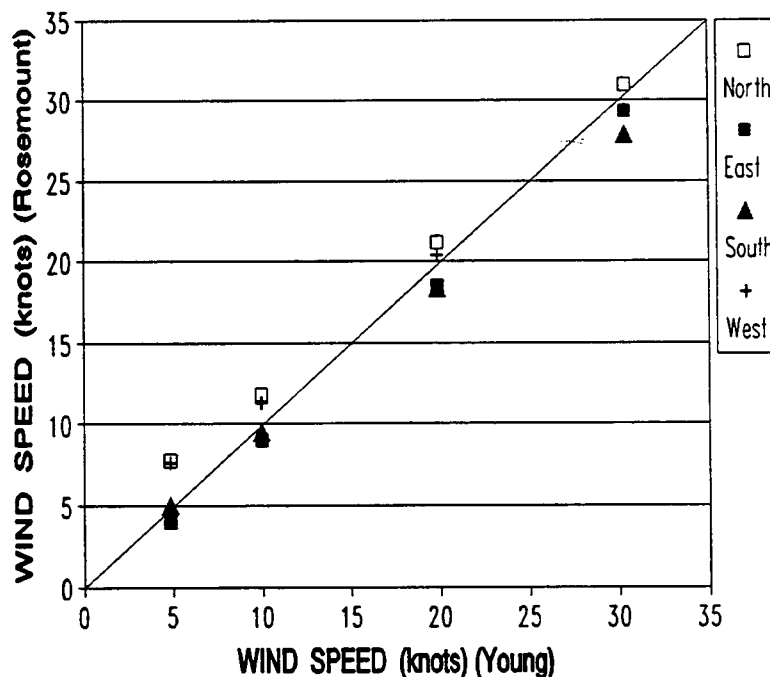
FIGURE 5-6. ROSEMOUNT CALIBRATION (S/N LLWAS1)

Figures 5-6 and 5-7 show the calibrations of the two Rosemount sensors. Four wind directions (north, east, south, and west) were tested for most wind speeds. RS1 (S/N LLWAS1) had been modified during the field testing to improve its response at low wind speeds. This modification limited RS1 to measuring wind speeds to a maximum of about 35 knots. RS2 (LLWAS2) was tested at wind speeds over the normal range (up to 42 knots).

Both Rosemount sensors showed somewhat greater differences from the R. M. Young reference sensor at low wind speeds than at high wind speeds, as would be expected for a pressure sensor. Since the signal is proportional to the square of the wind speed, a pressure offset will produce a greater error at lower wind speed. The modified RS1 sensor did show at best, a slight improvement in performance over the other Rosemount unit at the low wind speeds, but the improvement was at the cost of

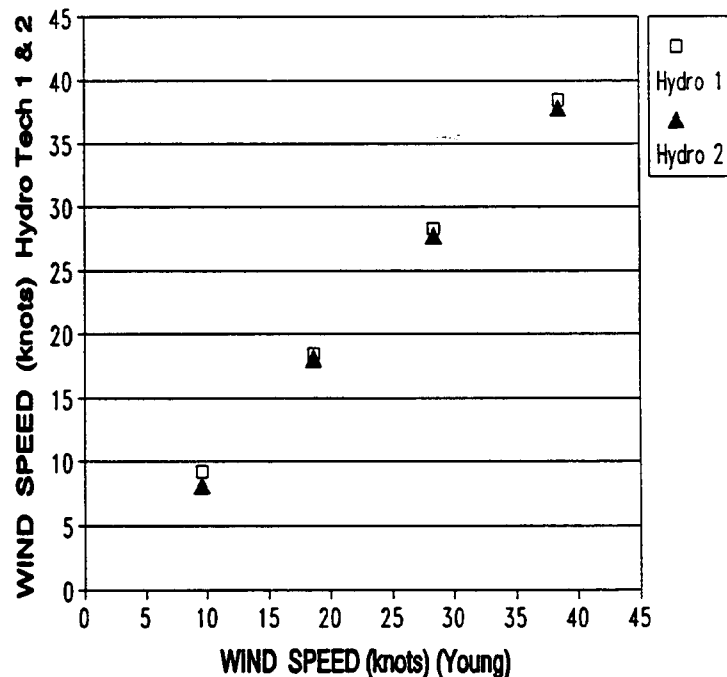
FIGURE 5-8. HYDROTECH CALIBRATIONS (S/N 131, 132)

Figure 5-8 shows the calibration for the two Hydro Tech anemometers. Their response was consistent at high speeds, but somewhat different at low speeds. This difference represents the high starting threshold noted in section 5.2.4.
